CARRIER SUITABILITY DEMONSTRATION

SP-1564

IDEA-0084-70
COPY 1 OF 2*Lockheed Aircraft Corporation***ADVANCED DEVELOPMENT PROJECTS**
BURBANK, CALIFORNIAREPORT NO. SP-1564
DATE 1-12-70
COPY NO 1**MODEL** U2-R**TITLE** CARRIER SUITABILITY DEMONSTRATION

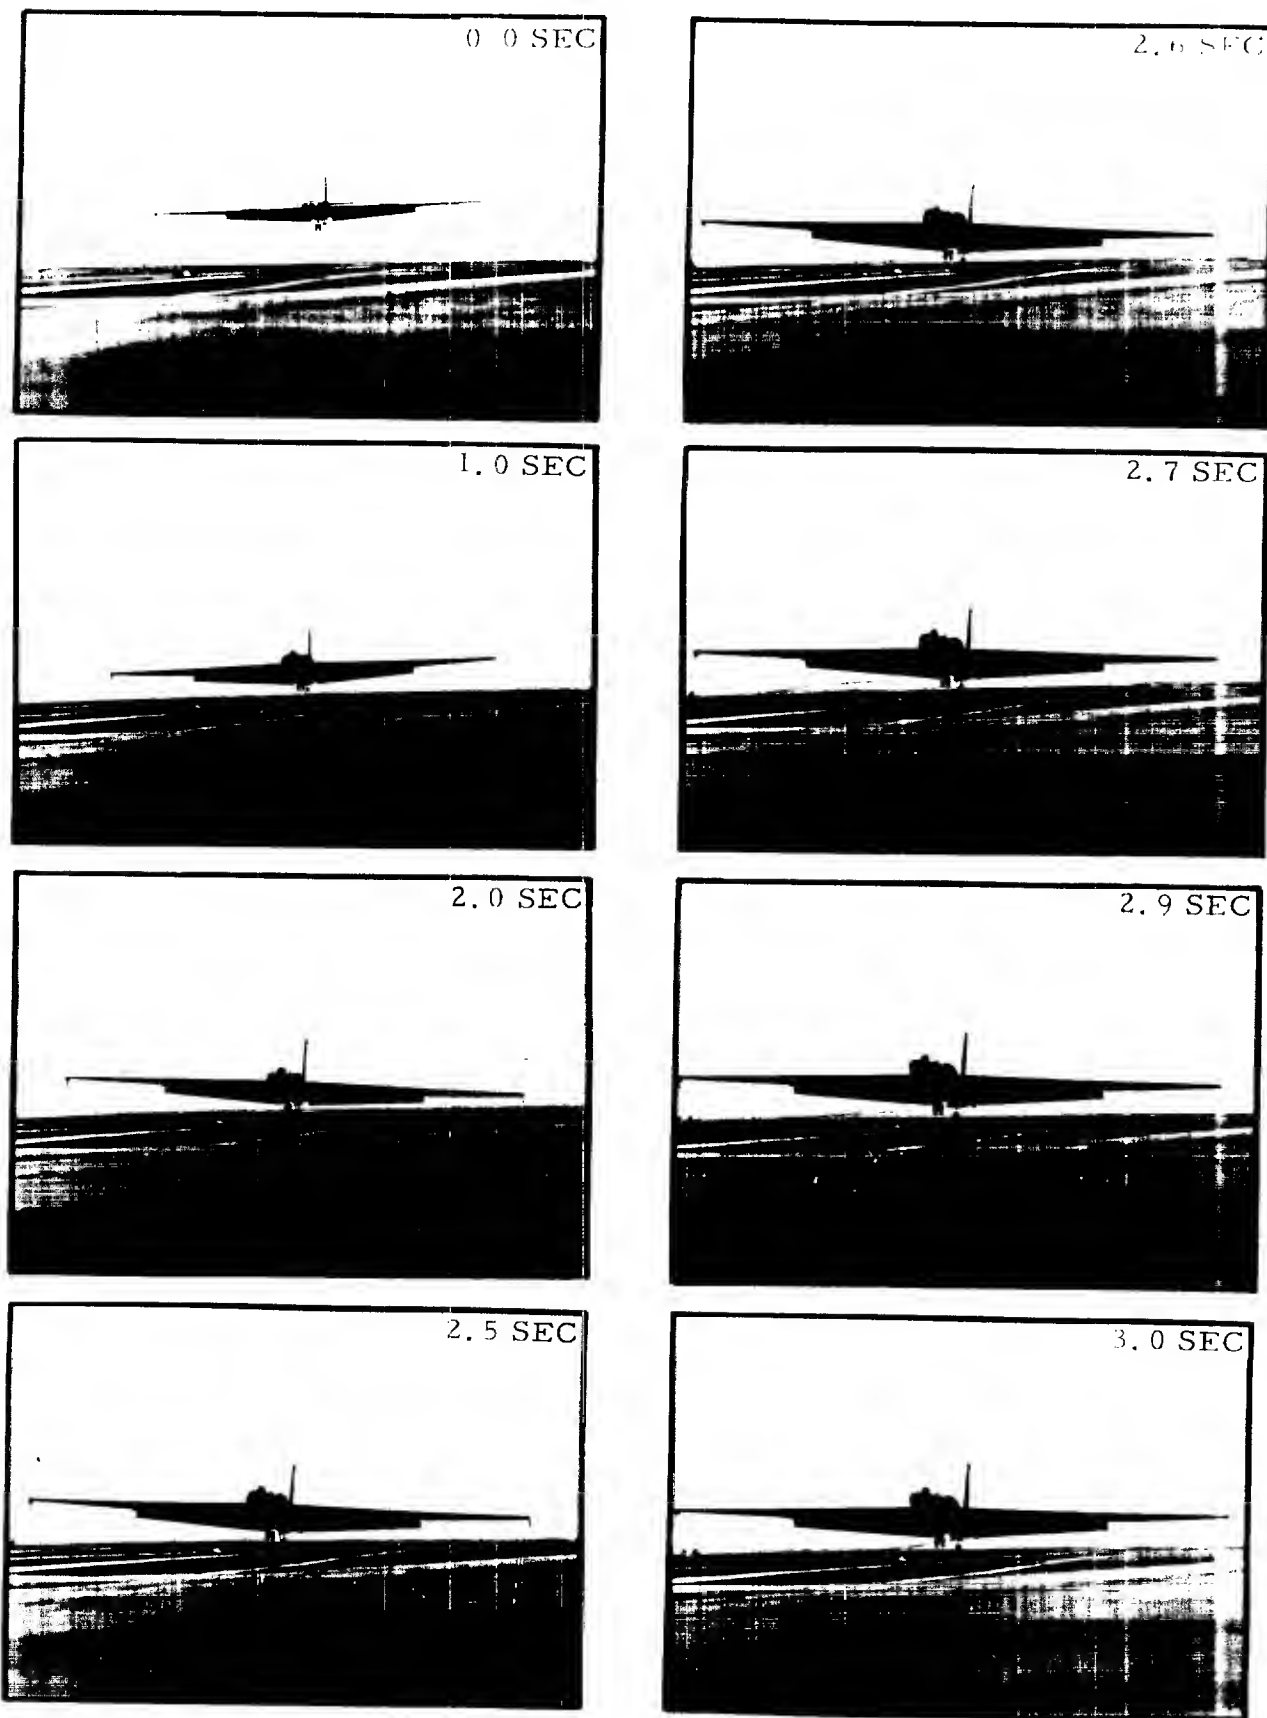
FIG. 1 SECOND LANDING

The second landing was much better than the first one. Although the same conditions were encountered on final approach, the wings were held level at landing and through the runout. On both landings the aircraft was steered with the rudder pedals during runout. Wind speed at arrestment was 30 knots on the second landing.

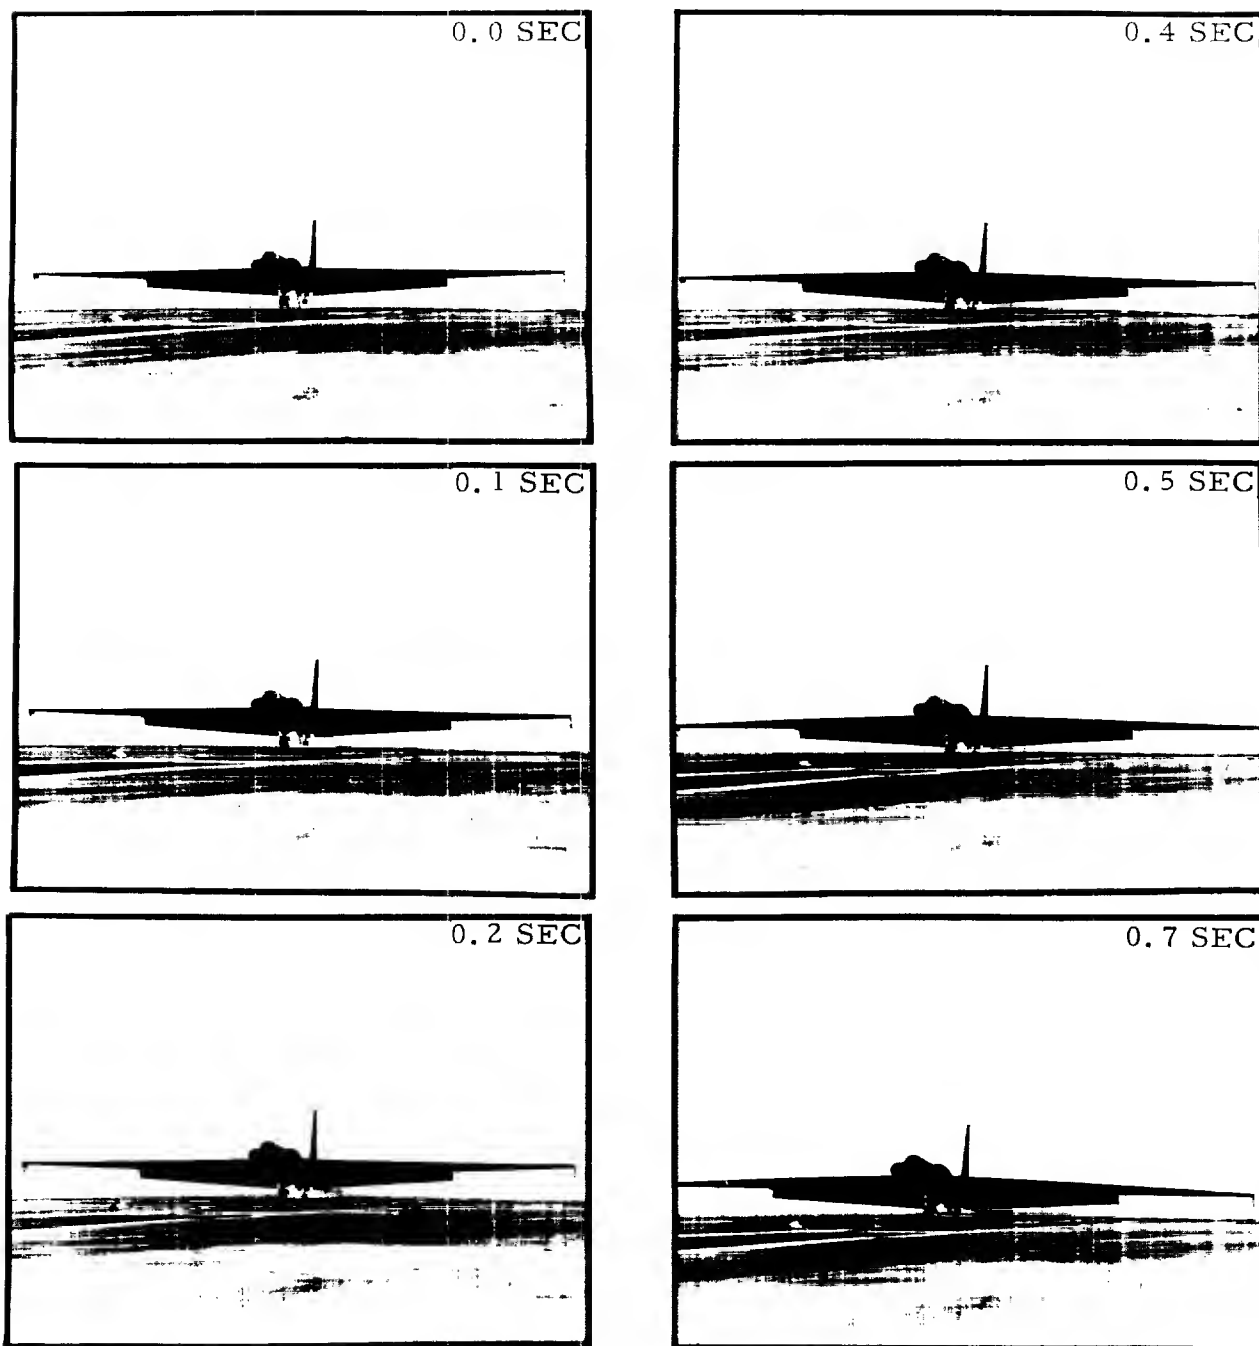
Damage to the underside of the fuselage was minor but did require a repair after the program was completed. The damage is caused by the hook hitting the structure either at initial arrestment or when the hook bounces up from the deck. Figure 8. High speed photos show one case where the hook hit the deck and bounced up against the fuselage and apparently missed hooking the #1 cable. Figure 9. The hook bouncing did not start until after seven arrestments. The liquid spring hook damper was found to have lost its charge when checked at the completion of the program. The lack of damping was not noticeable to the men manually cocking the hook on the deck. It is assumed that the damper lost its charge sometime prior to the eighth arrestment.

The damper had been serviced prior to the runway tests at Lakehurst in September 1969. During the Lakehurst tests it was subjected to ten taxi arrestments and two landing arrestments. Engaging speeds in the Lakehurst tests were much higher than those on the carrier. Prior to deployment to Wallops Sta. the damper was checked and found to be satisfactory and did not require reservicing. Pictures taken of the hook on the first landings show it staying "glued" to the deck from initial contact until it picked up the cable. The damper is under investigation and appropriate corrective action will be taken.

FIG. 9 HOOK BOUNCE CAUSED BY DEFLATED HOOK SNUBBER
